Cleaning the print head

Replacing the xenon lamp unit

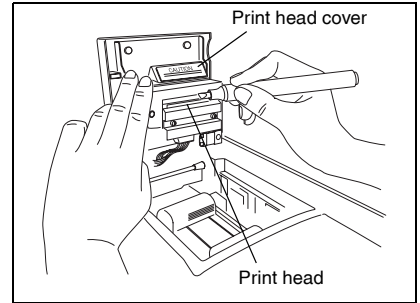
- ❶ Flip off the SC-2000USB's power switch.
- ❷ Open the ink ribbon compartment cover, then pull back the print head cover.
- ❸ Use the enclosed print head cleaning pen to gently wipe back and forth along the print head.
 - ⚠ *Be careful not to touch the print head.
Keep the cap on the print head cleaning pen when it is not being used.*
- ❹ Release the print head cover and close the ink ribbon compartment cover.
- ❺ Try printing again.
- ❻ If the printed characters are still blurred, repeat steps ❶ through ❺.

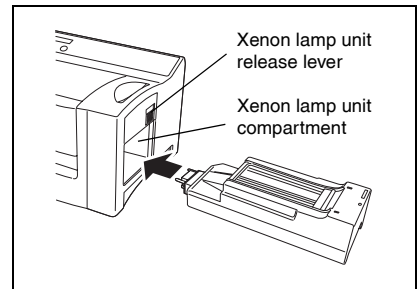
The xenon lamp unit has a life span of approximately 2000 flashes. When the message "REPLACE Xe UNIT" appears on the display, the xenon lamp unit must be replaced.

- ❶ Press the Mode button on the SC-2000USB until "RESET COUNTER" appears on its display, then press the Set button.
- ❷ Slide the xenon lamp unit release lever up and pull out the xenon lamp unit.
- ❸ Fully insert the new xenon lamp unit until it locks into place. Check that "N = 0" appears on the display of the SC-2000USB.
- ❹ Press the Set button on the SC-2000USB.
